SE corner and east face of ~~XX~~ 90  
89

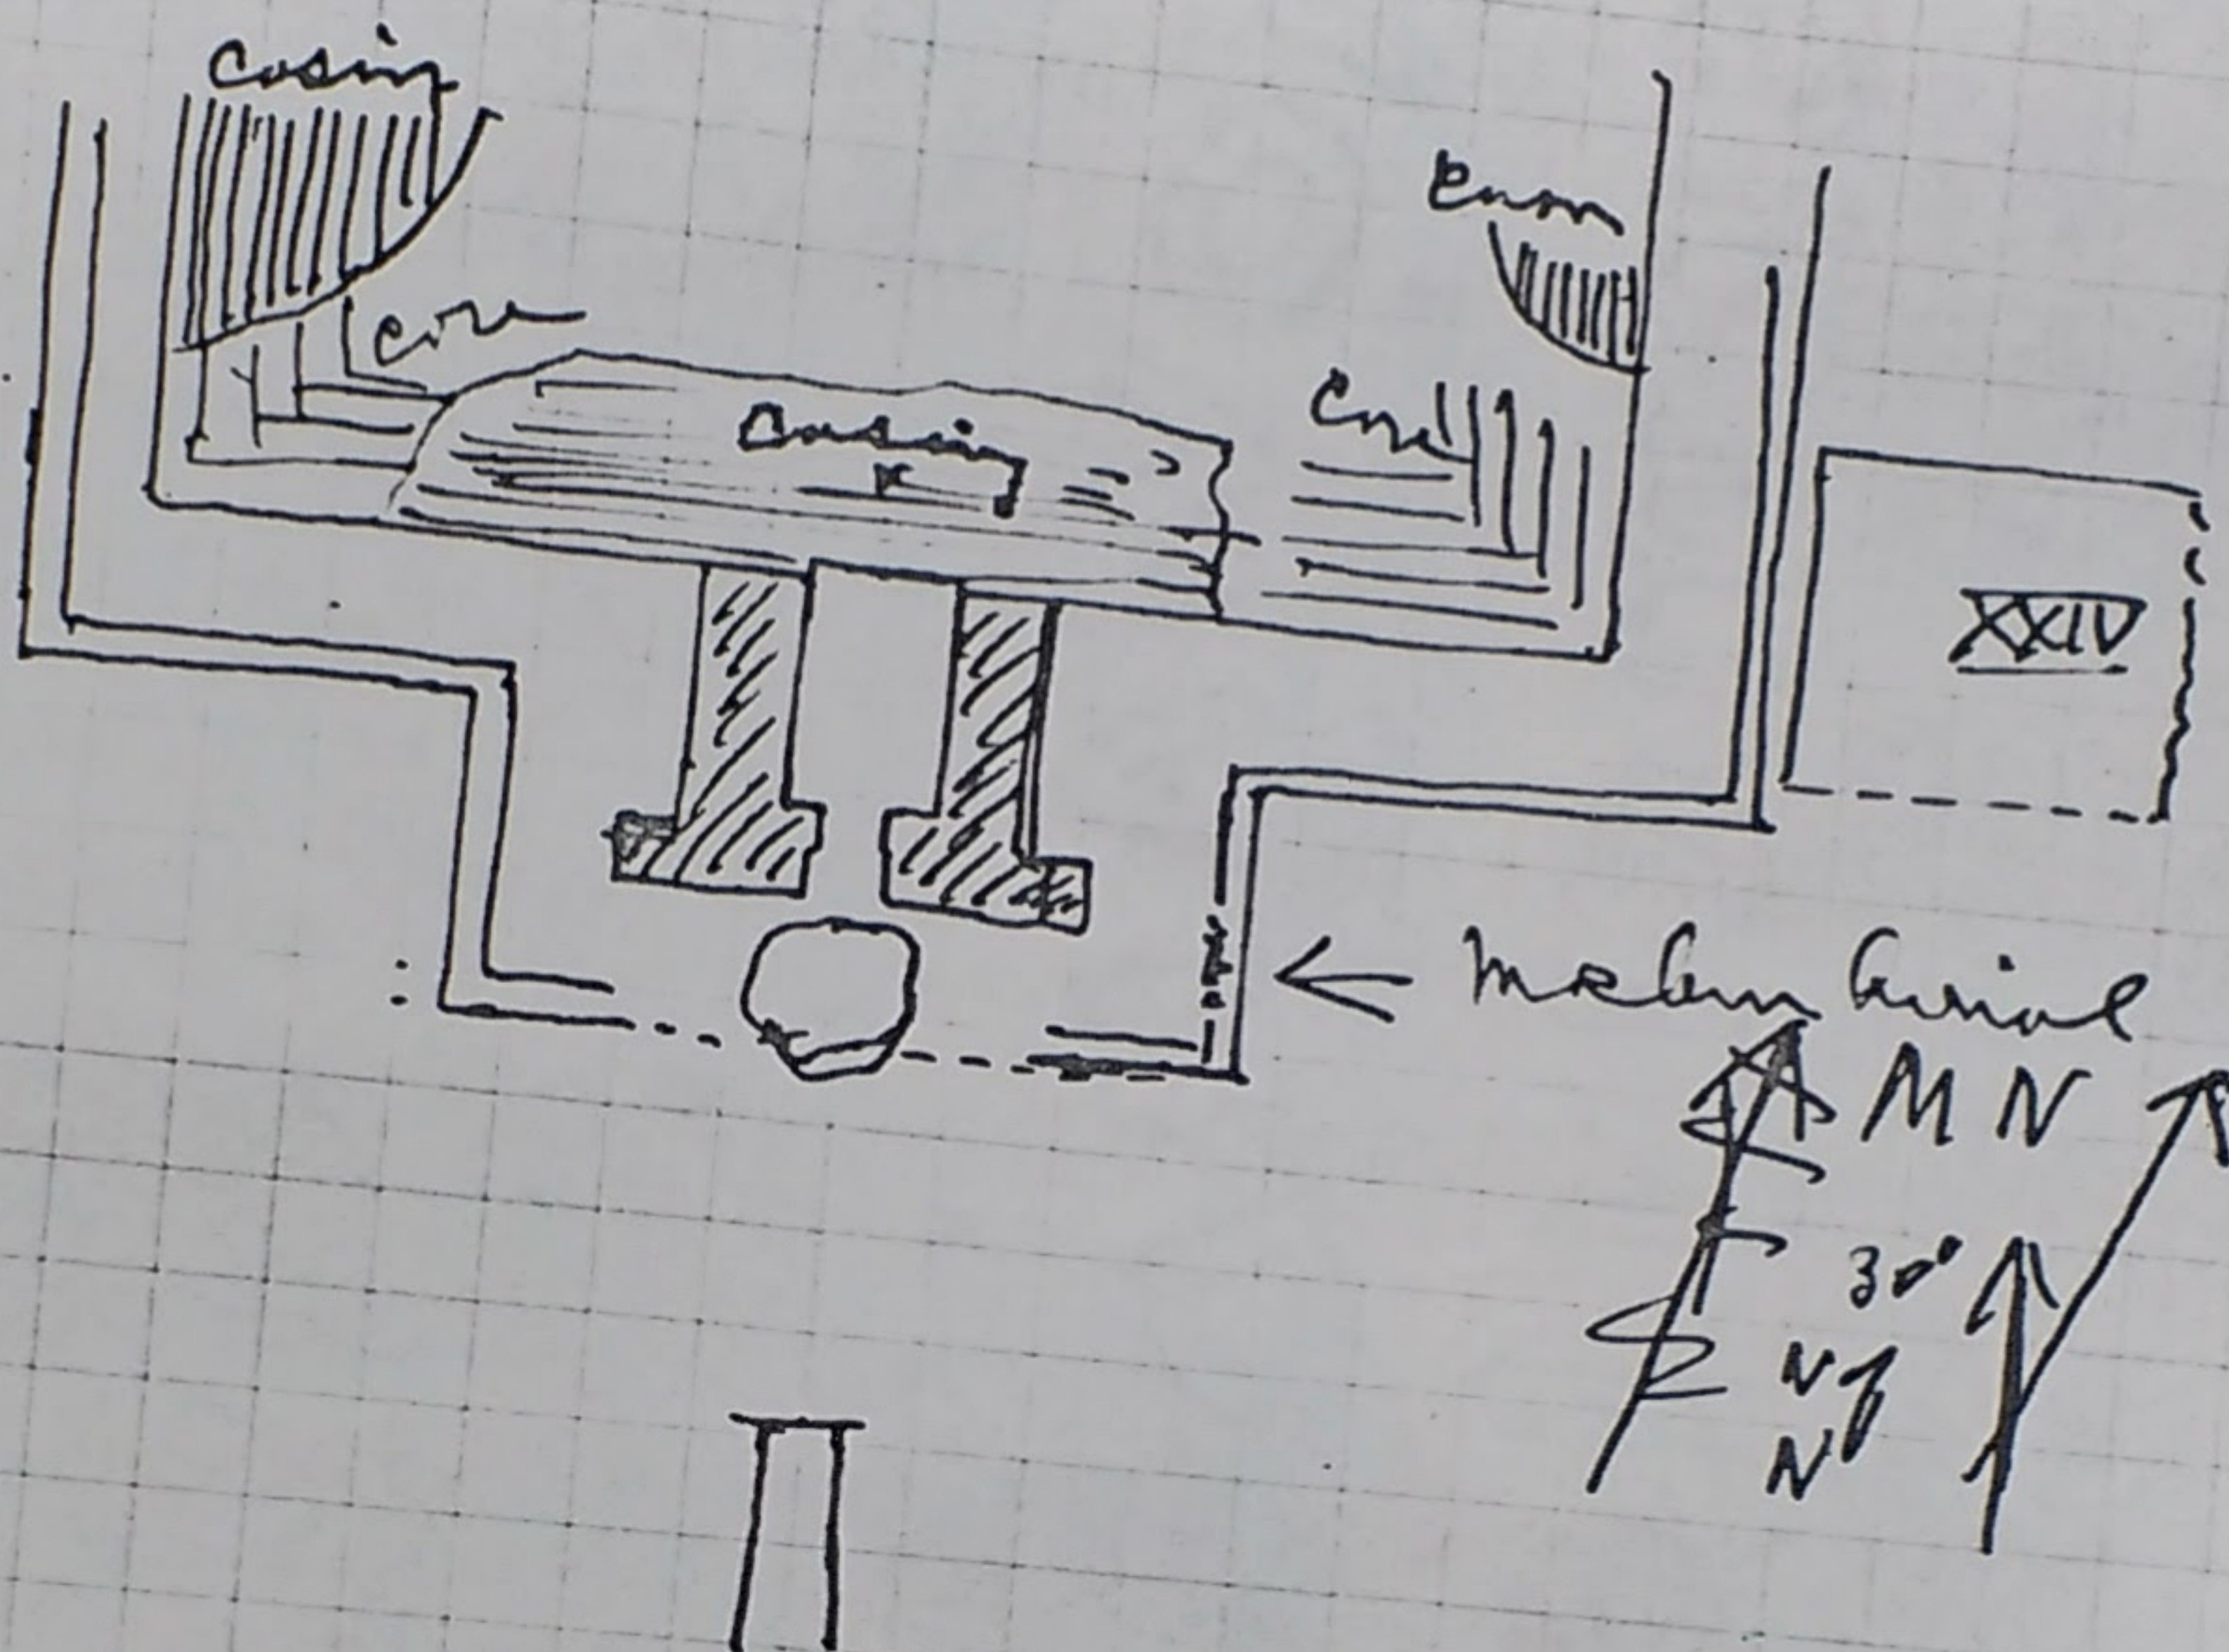
The greater part of the N. galls were on this clearing. The casing has been destroyed at the SE as at the B. W. corner, but appears again further N along the E face. The core wall is well built in distinct steps which took the casing courses. ~~At the~~ In the E wall of the platform wall (S. projection) was a burial (apparently Muslim?).
