(Munk 2)  
34

162  
~~68~~

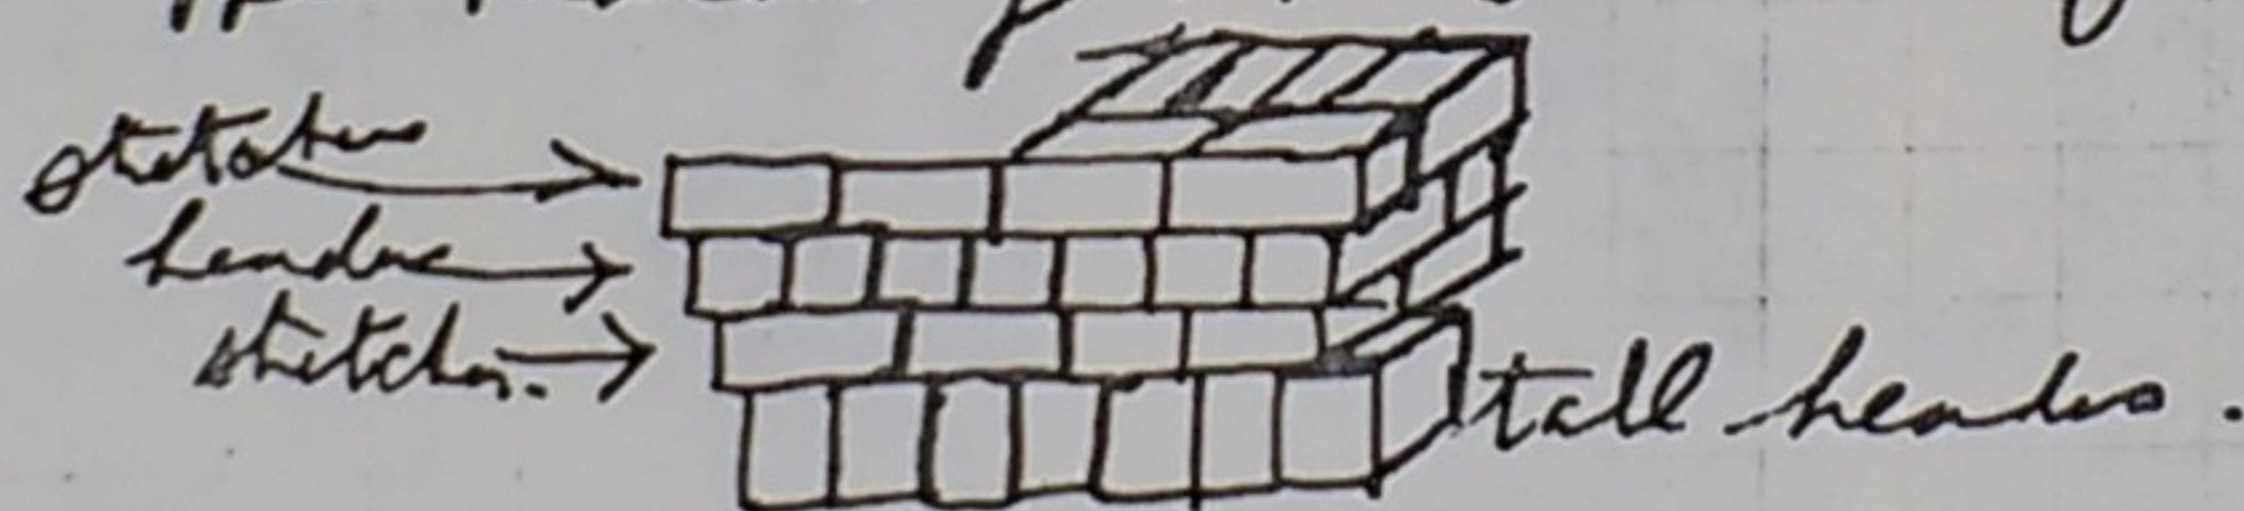
The masonry at X is as follows:

So far as preserved. The stones are large  
and poorly dressed. Around the corner  
at Y, the small masonry (beautifully  
square stones laid in grey mortar, harder  
than the stone) is as follows.
