March 15  
45

Thursday  
March 16  
46  
working  
day.

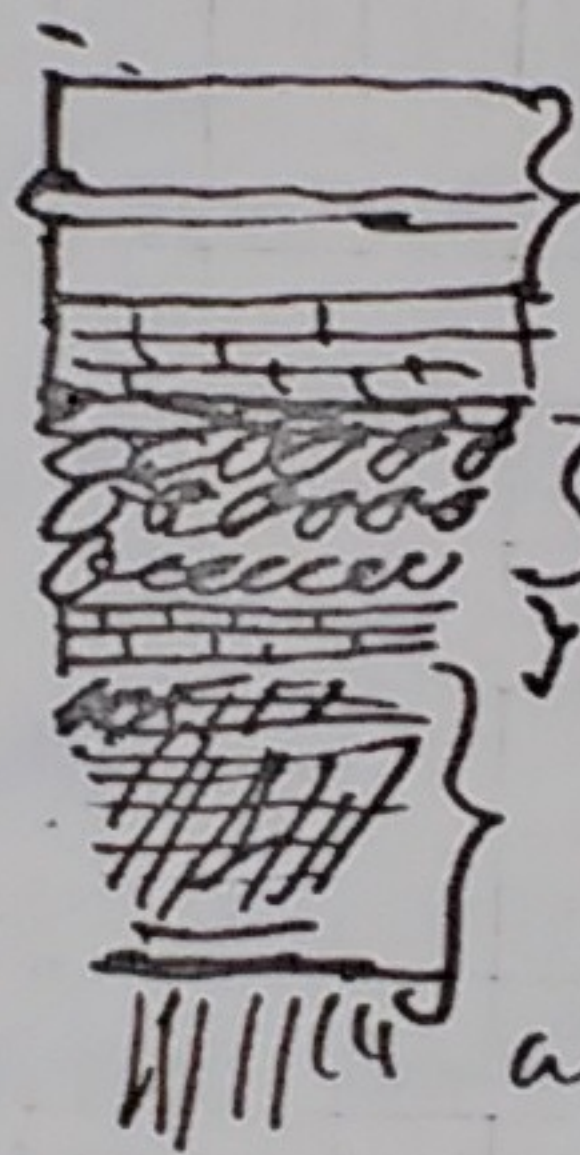
when the men were sent to (97) 189  
Bldg 100, to clear up for  
survey and photography.  
Near the NW door I sunk a  
pit part the foundations into  
alluvial soil. The wall is founded  
on rubble over 2 courses of red-bricks

plastered  
bricks red  
rubble  
red bricks  
mud, stones pot shards, etc.  
alluvial sandy mud.

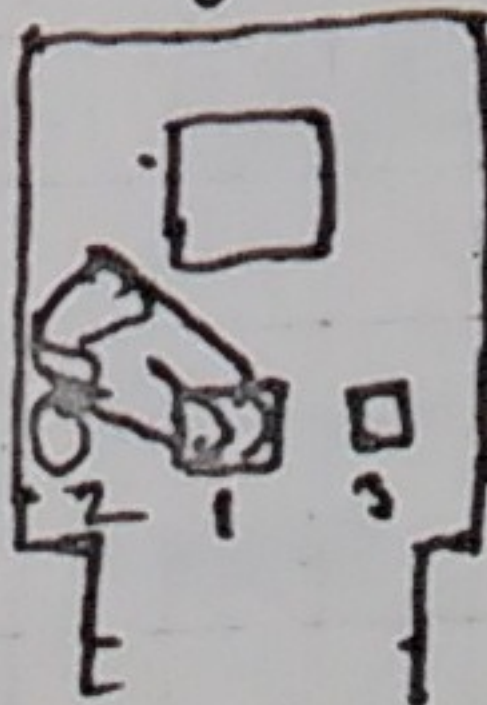
clearing 703. At back small room.

- a recess room - no. 704 - filled with

dirt and fallen stones. In the middle

a small uninscribed <sup>granite</sup> altar or more  
probably <sup>pedestal</sup> base for a statue.

- 1 a battered sandstone statue  
lying in ruins.
- 2 small granite statue of a  
bearded god (not very good)
