- ⑥. On the east face of the N. end of the great  
tangle (500) began examining the debris along  
the outside of the wall. <sup>Bldg. 500, Trench D.</sup> There is a clear  
restoration here.

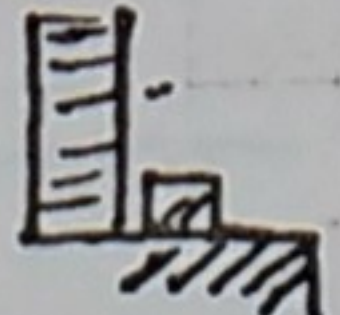
A well-laid wall  
(mortar) of small stones of uniform size, is  
built off a roughly built wall of larger stones  
(dry-laid?). (later note:- wall of larger stones built  
against wall of small stones).
